CHAS-341
RICHARD BLAND HOUSE
Vicinity of Gallant Green
Private

INVENTORY FORM FOR STATE HISTORIC SITES SURVEY

RICHARD BLAND HOUSE

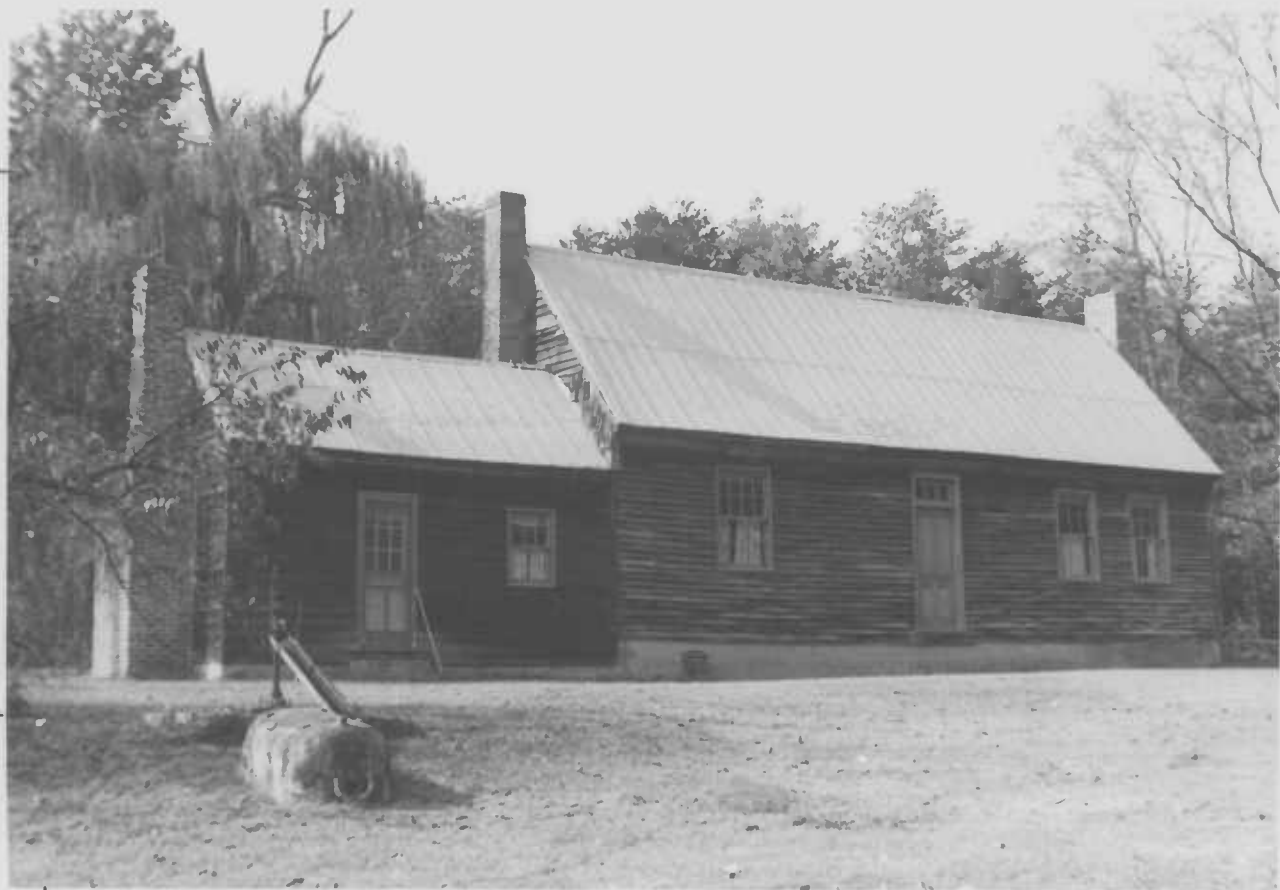
N. Front

The north front is four bays in width, having a transomed entrance door located in the third bay from the west end and flanking windows of 6-over-6 double hung sash. On the opposite side the house is three bays, with a transomed entrance door occupying the third bay from the west end. A one-bay, shed-roofed extension occupies the area between the door and the east end of the house; the remaining wall area is covered by a shed-roofed porch. At each end of the main block is an exterior chimney. The entire west chimney and the stack of the east chimney have been rebuilt in recent years; however, the base of the east chimney survives and has stepped weatherings below what was a free-standing stack.

One of the most important exterior features of the house is the presence of its original, beaded, riven clapboard siding on the front and most of the rear elevations. The roof of the house was also sheathed with riven clapboards, portions of which can be seen beneath the roof of the south porch. The presence of similar roof sheathing beneath the roof of the south shed extension indicates that it and the porch were added after the main block was built. There is other evidence to indicate that a shed-roofed porch also extended the full width of the north front. The ends of the house and the south rear wall of the south extension were resheathed in later years.

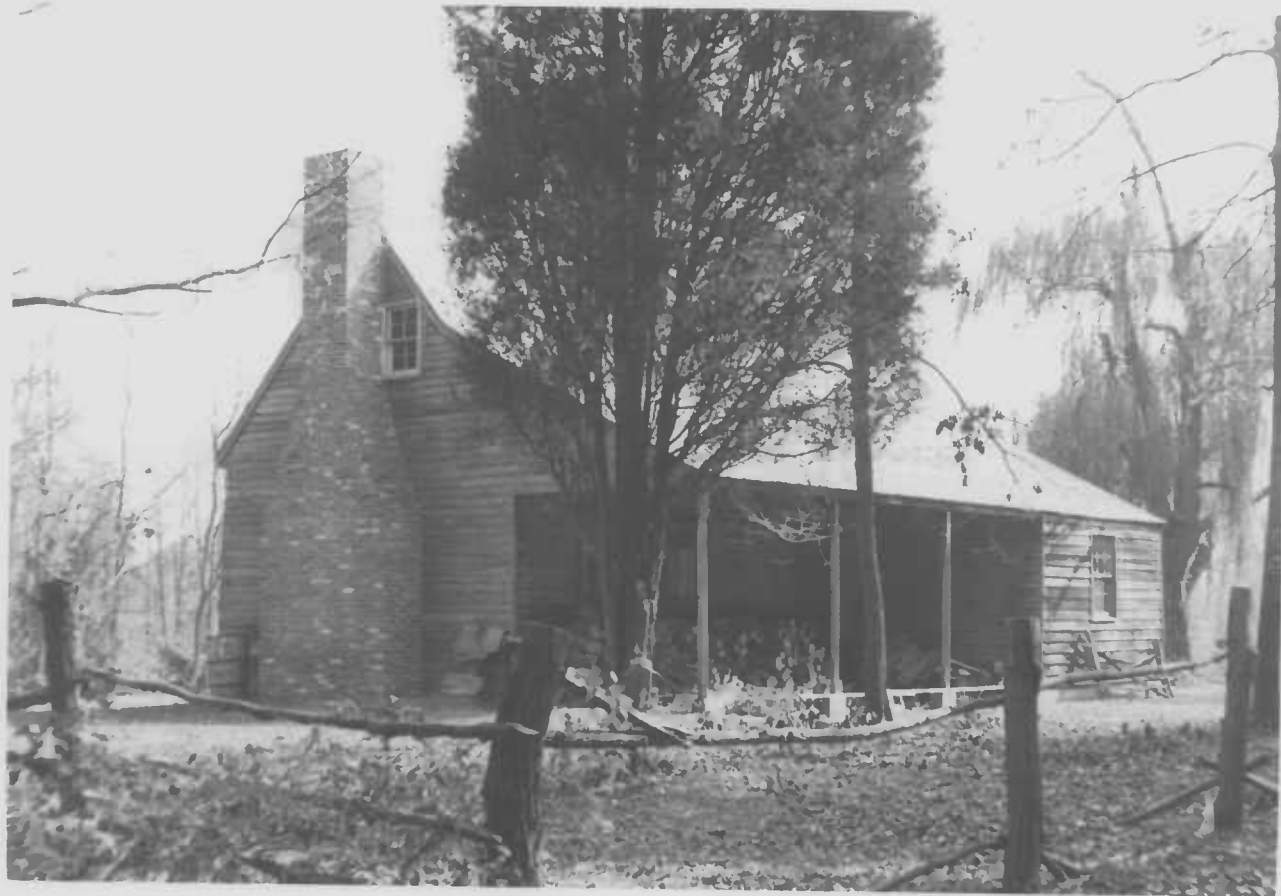
SW Ele. J.R.Rivoire, 1978

At the east end of the house stands a small kitchen wing with an exterior end chimney, two bays wide on the north front and one bay wide on the rear side. The entrance door occupies the first bay in from the east end of the front elevation. The chimney, with stepped weatherings on all three sides, has a later and crudely fashioned stack. With the exception of the siding, most of the trim, windows and doors are of a later date. The two entrance doors of the main block are of a mid- or late nineteenth century date, while the windows and trim appear to be of even more recent origin. However, the trim is of a basic profile appropriate to the probable construction date of the house. The trim is painted a pale rose color that with the weathered gray of the siding presents a most attractive exterior appearance. The house stands on brick foundation walls, but the north foundation has been covered by cement. The roof on both parts of the house has been recently sheathed with tin.
